# Rocky Bluffs Property Owners Association

## Level 2 Reserve Study

**Report Period - 1/1/2020 to 12/31/2020**

**Report prepared on – January 23, 2020**

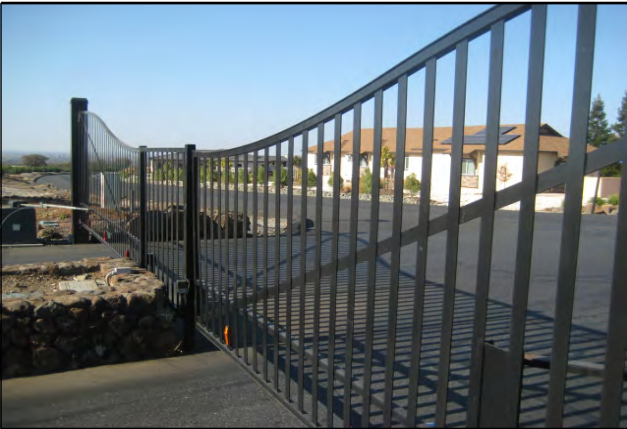
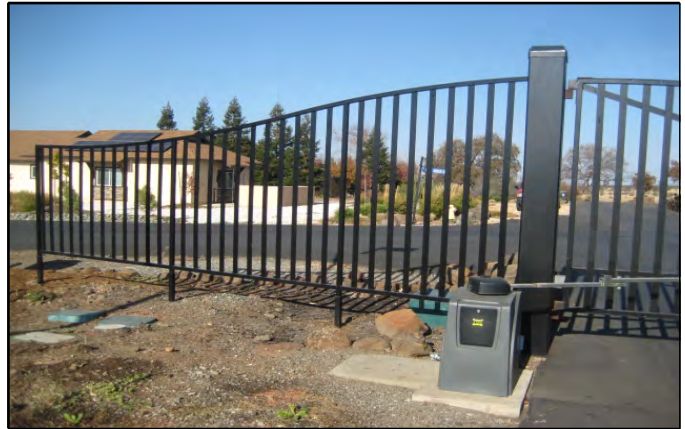
Metal entry gates/fencing will require regular cycles of paint/sealant to help prevent corrosion. The majority of gate surfaces appeared to have been recently painted. This component has an approximate useful life of 4-6 years. The remaining useful life is based on current condition.

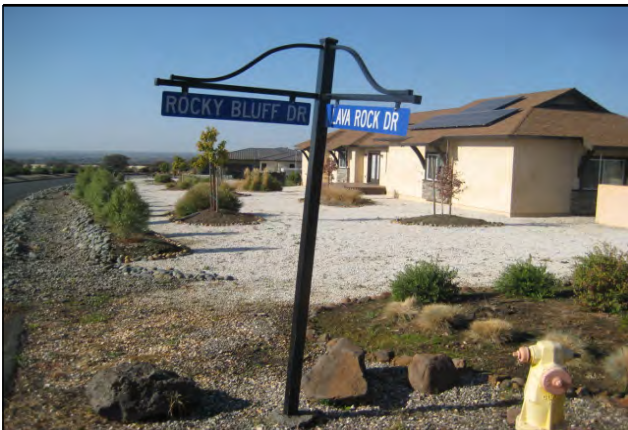
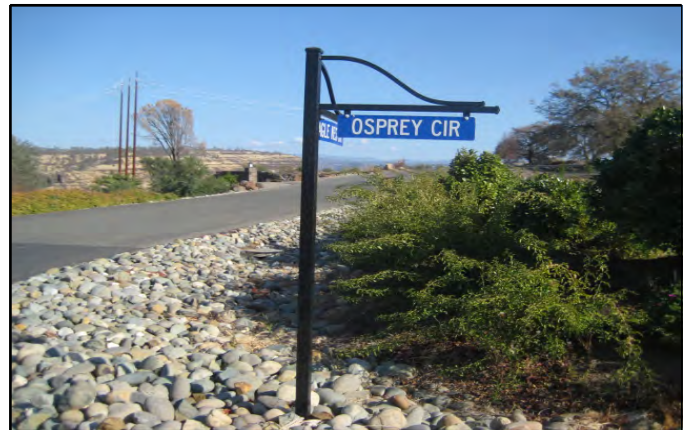
Due to moderate amount of sign posts, this component is typically a lower cost item and can be maintained as-needed through the operating/maintenance budget.

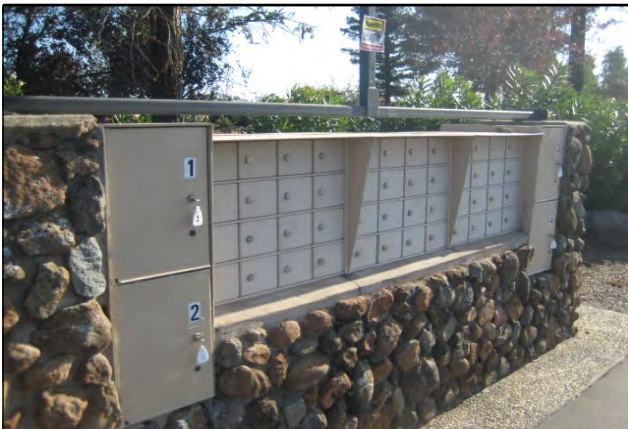
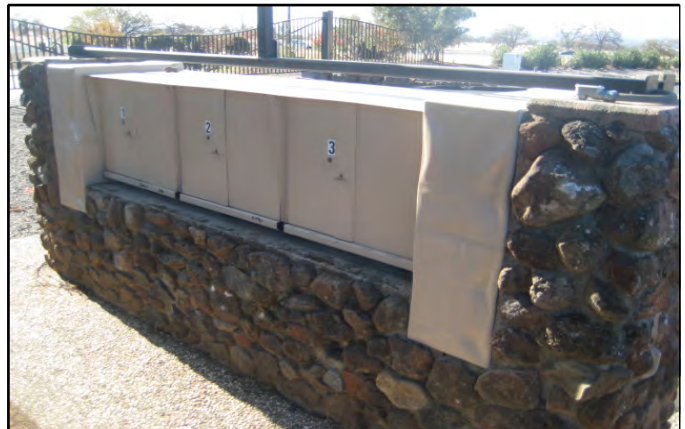
Exterior metal surfaces will require regular cycles of paint/sealant to help prevent corrosion. The mailboxes were reportedly last painted in 2014 at a cost of \$875. This component has an approximate useful life of 4-6 years. The remaining useful life is based on prior project date.

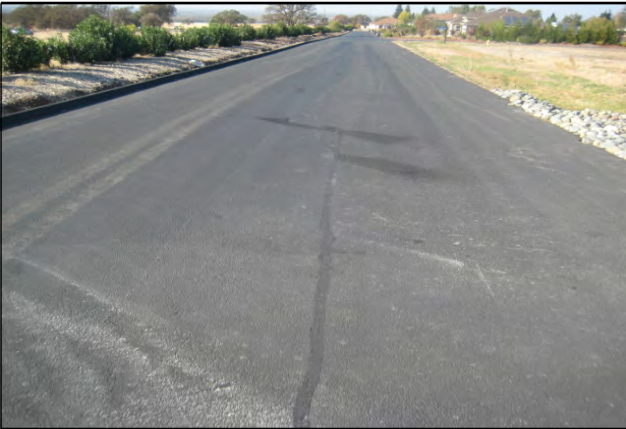
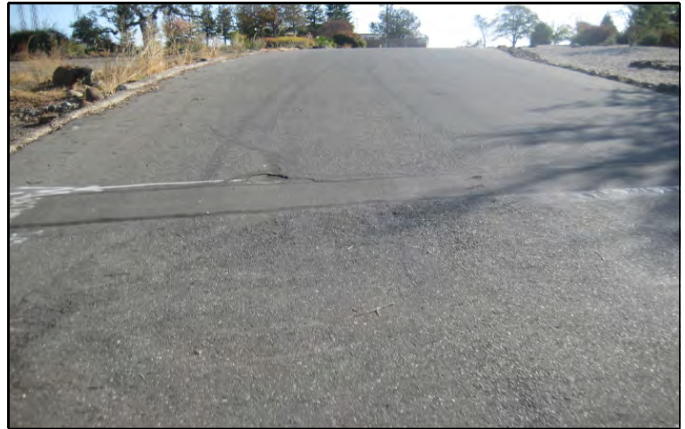
Although there were random areas of deterioration, the majority of asphalt appeared in stable condition. This component typically has an approximate life of 30-40 years, but preventive maintenance (see next component) may prolong typical useful life before major rehabilitation may be needed (resurfacing, overlay, etc.).

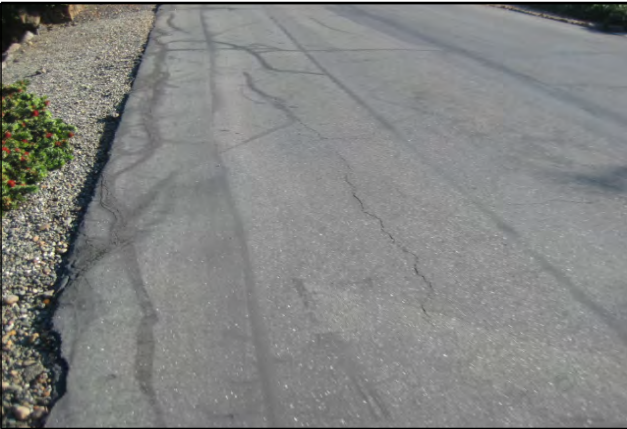
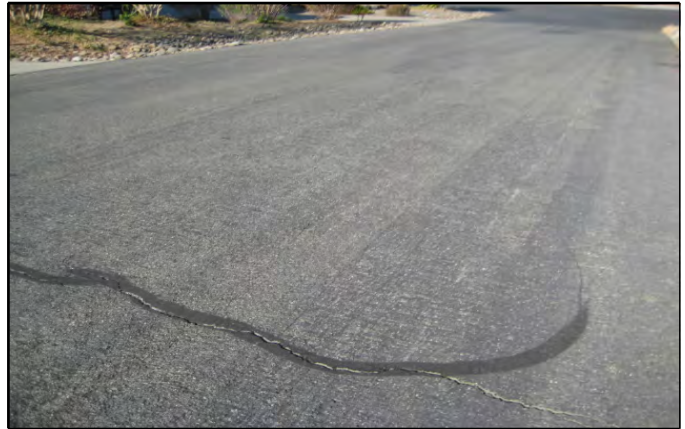
Asphalt was reportedly seal coated last in 2012. Regular cycles of preventive maintenance and asphalt seal coating is key to extending the typical useful life cycle for major rehabilitation projects. This component typically has an approximate life of 4-6 years. The remaining useful life is based on the prior project date and current condition.

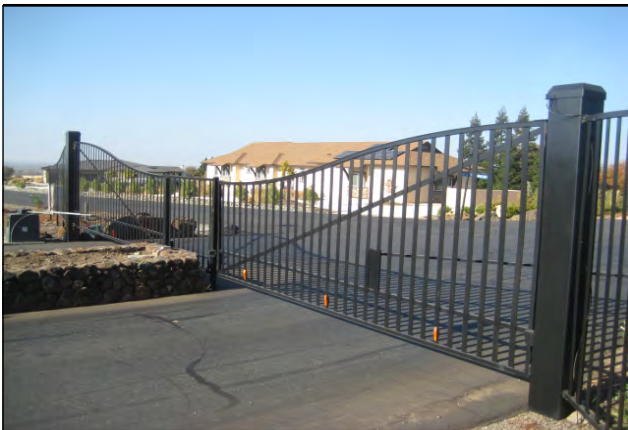
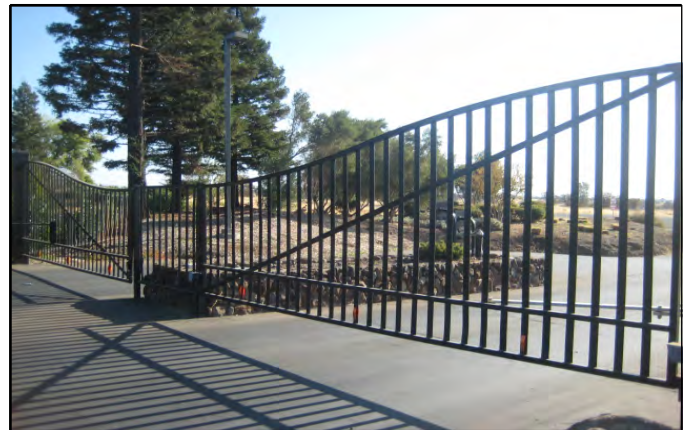
Comp # 504 Vehicle Gates - Replace

Although long lasting material, metal gates will require eventual replacement. This component has an approximate useful life of 25-35 years. The remaining useful life is based on the assumed age.

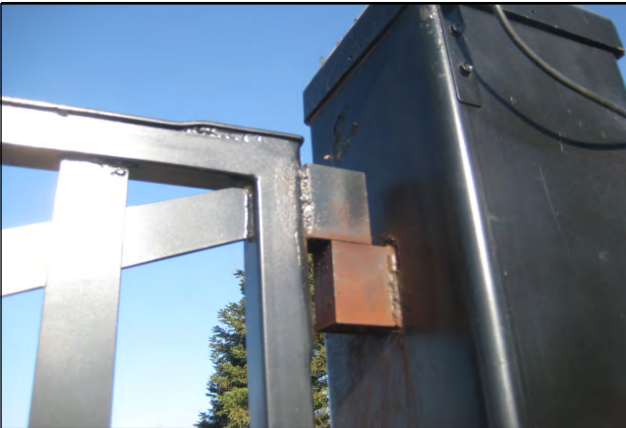
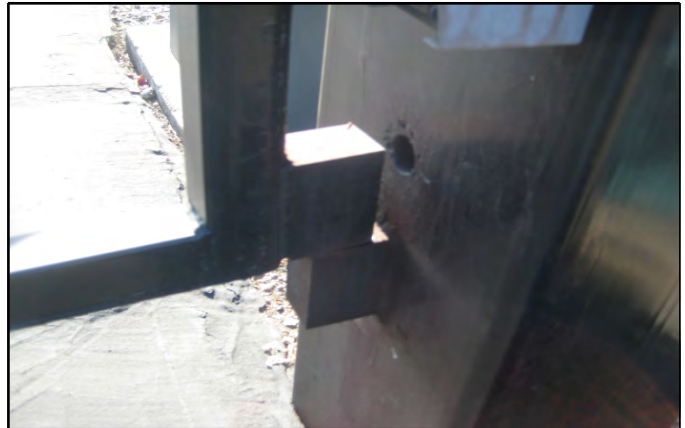
Comp # 505 Vehicle Gate Hinges - Repair/Replace

Functional condition observed, no problems reported. This component represents ongoing cycles of repair/replacement as gate hinges will wear out faster than other parts of the gate system.

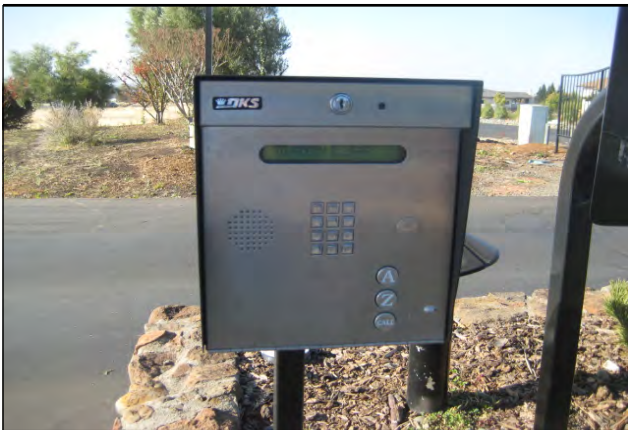
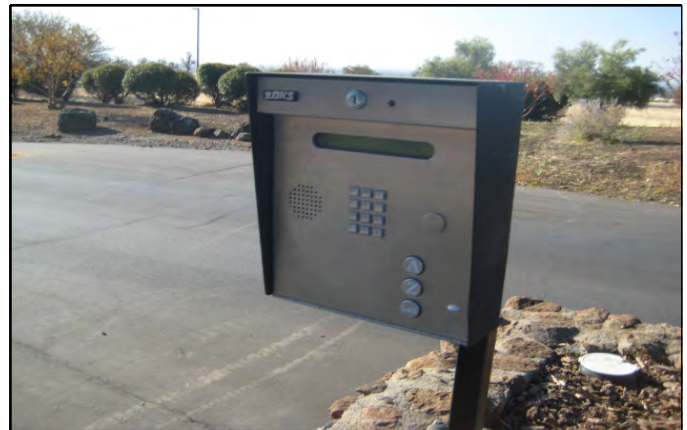
Comp # 506 Phone Entry Panel - Replace

Functional condition observed, no problems reported. Last replaced in 2014 at a cost of \$3,430. This component has an approximate life of 10-20 years. The remaining useful life is based on the installation date.

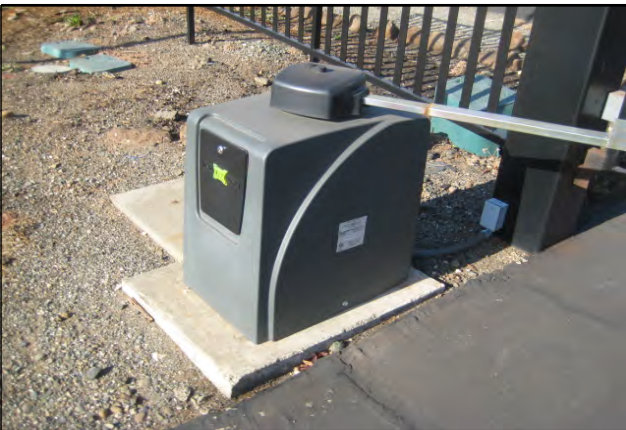
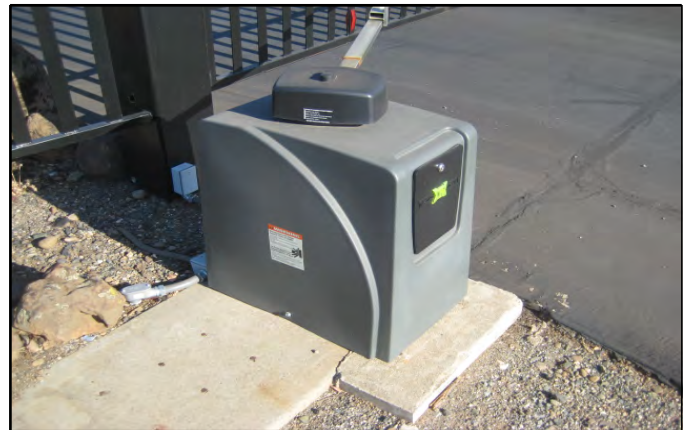
Comp # 507 Vehicle Gate Operator - Replace (A)

This operator was recently replaced at a cost of \$4,878. This component has an approximate life of 10-20 years. The remaining useful life has been extended based on the installation date.

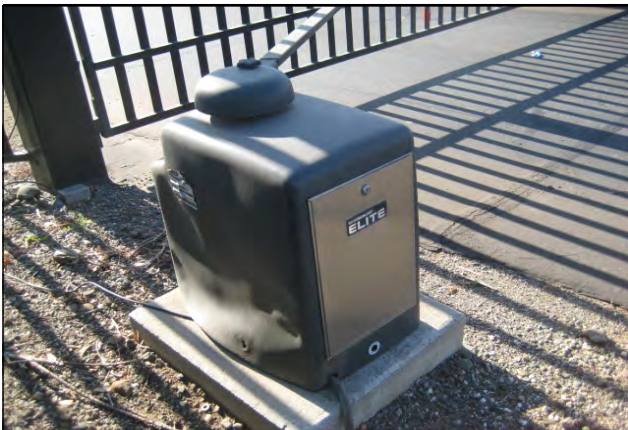
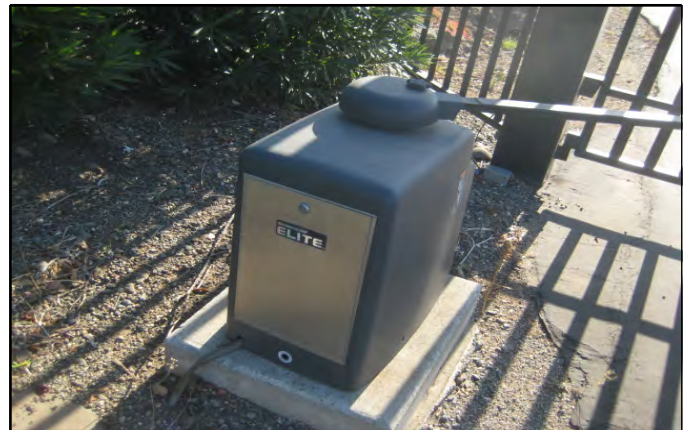
Comp # 508 Vehicle Gate Operator - Replace (B)

Functional condition observed, no problems reported. This component has an approximate life of 10-20 years. The remaining useful life has been extended based on the assumed condition.

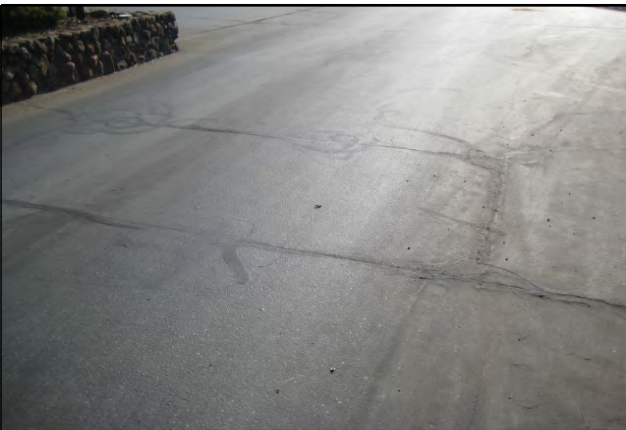
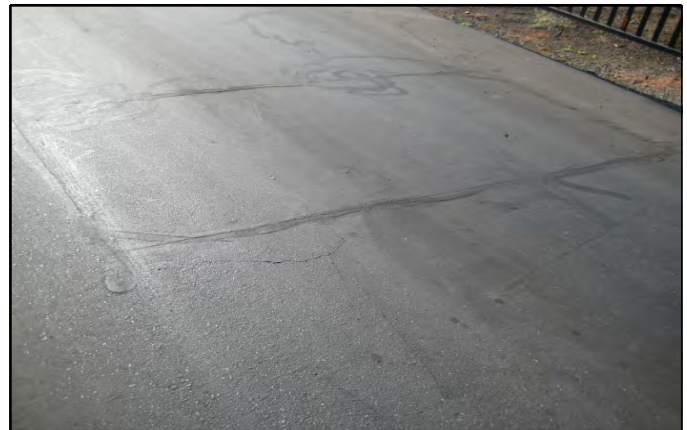
Comp # 509 Vehicle Gate Loops - Replace

This component represents a reserve allowance for eventual cycles of replacement of the vehicle gate loops. Monitor life cycle and costs closely and adjust as-needed in reserve study updates.

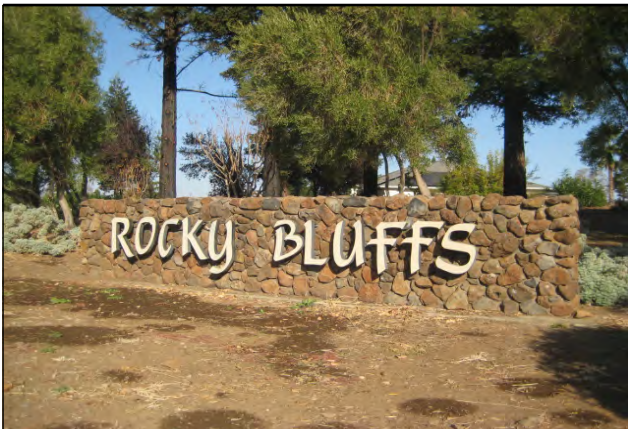
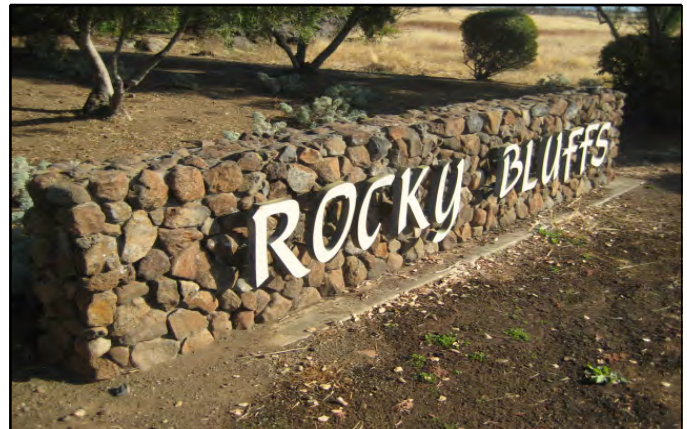
Although there is no expectation to completely replace the monument/sign under normal circumstances, we recommend funding for significant refurbishment approximately every 20 to 30 years. The remaining life is based on the assumed age.

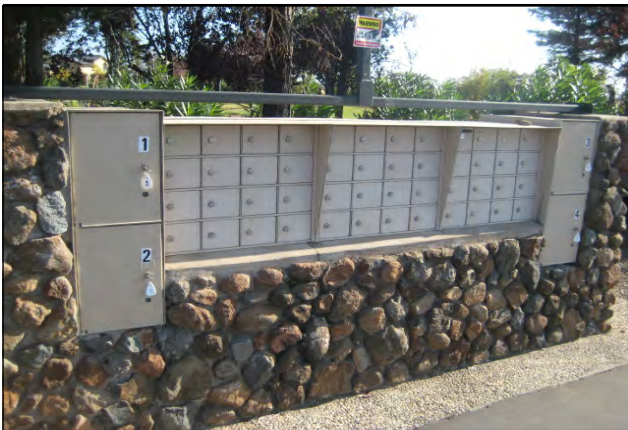
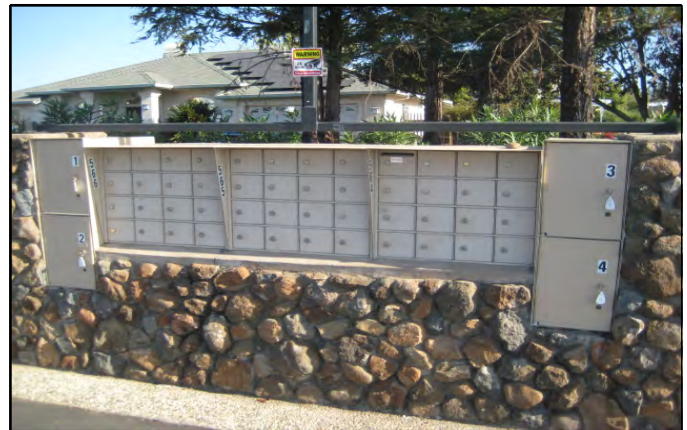
Comp # 803 Mailboxes - Replace

Although long lasting, mailboxes will require eventual replacement. This component typically has an approximate useful life of 15-25 years. The remaining useful life is based on the assumed age.

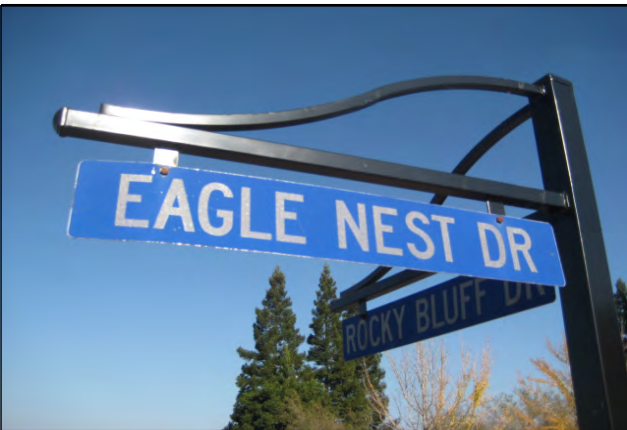
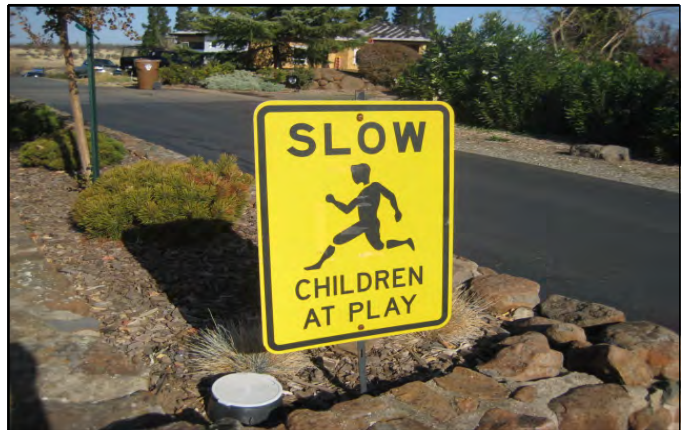
Comp # 808 Street Signs - Replace

Majority of signage appeared in fair condition. This component has an approximate life of 15-25 years. Remaining useful life has been extended based on assumed age.

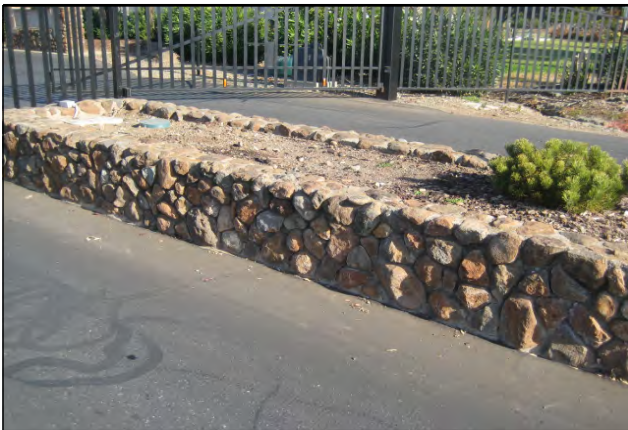
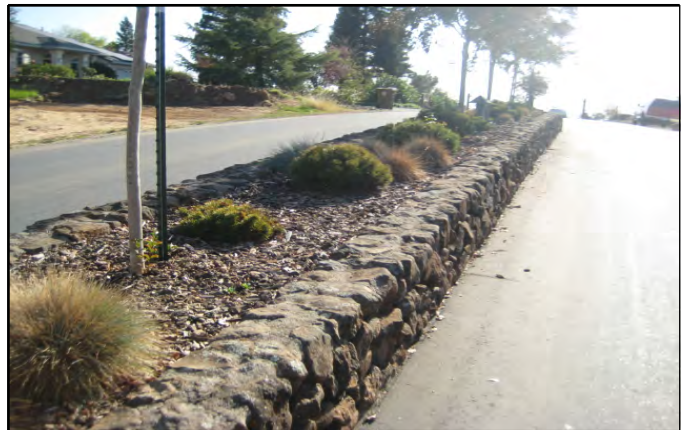
Comp # 1090 Stone Façades - Repair

This component represents cycles of repair to the stone façade planters on Rocky Bluff Drive. Monitor expenses closely and adjust as needed in reserve study updates.

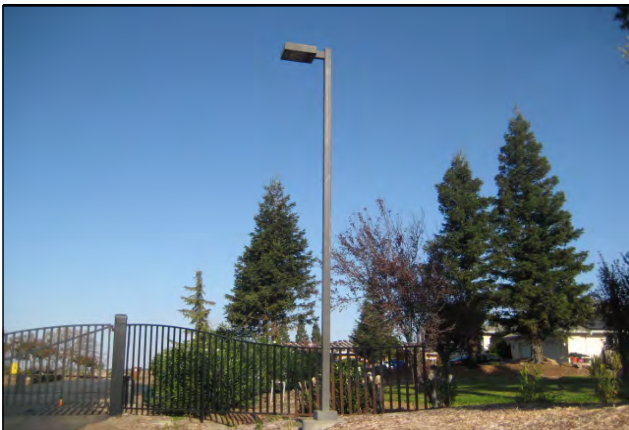
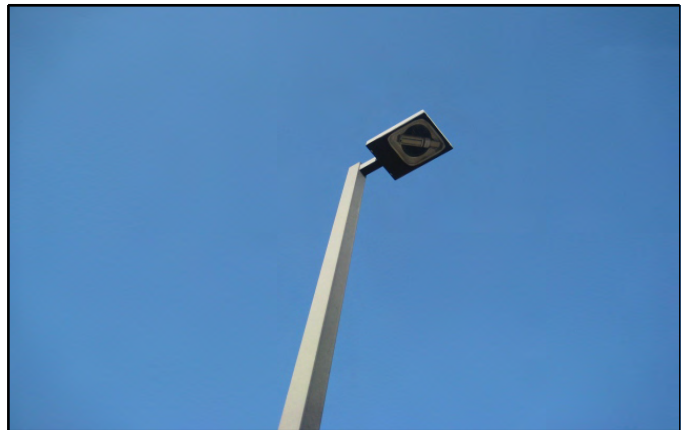
Comp # 1604 Pole Lights - Replace

Although pole lights and fixtures typically have an extended life, best to plan for eventual replacement. This component has an approximate useful life of 30-40 years. The remaining useful life is based on the assumed age.

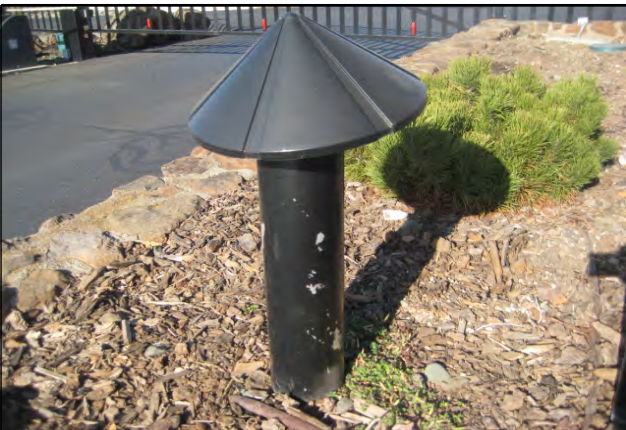
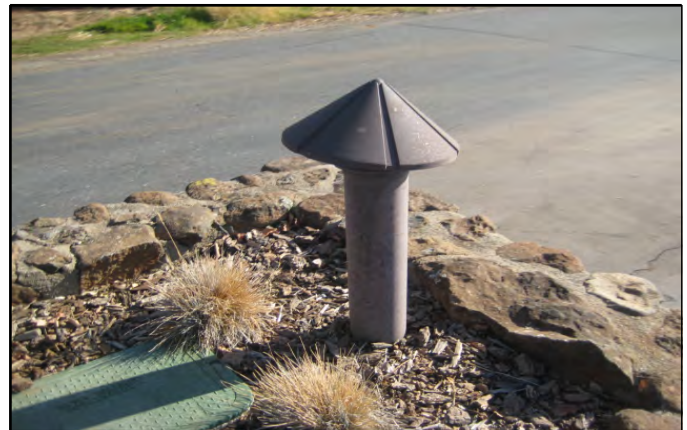
Comp # 1605 Mushroom Metal Lights - Replace

Observed during daylight hours, functional condition assumed. This component has an approximate useful life of 10-20 years. The remaining useful life is based on the assumed age.

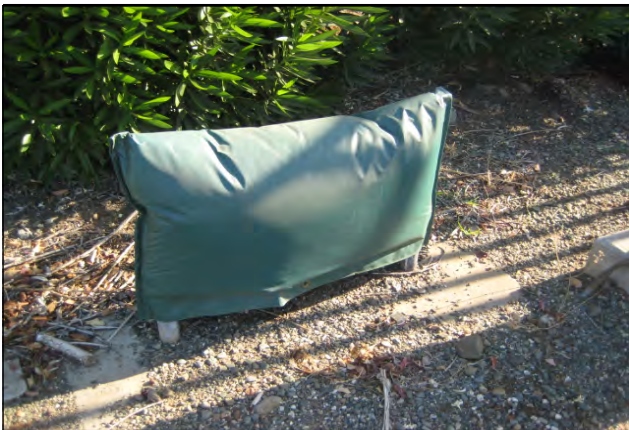
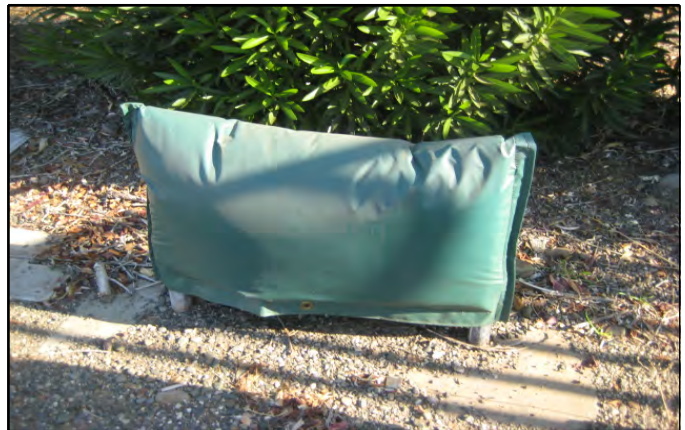
Comp # 1790 Backflow Device - Replace

Functional condition assumed, no problems reported. This component has an approximate useful life of 15-25 years. The remaining useful life is based on the assumed age.

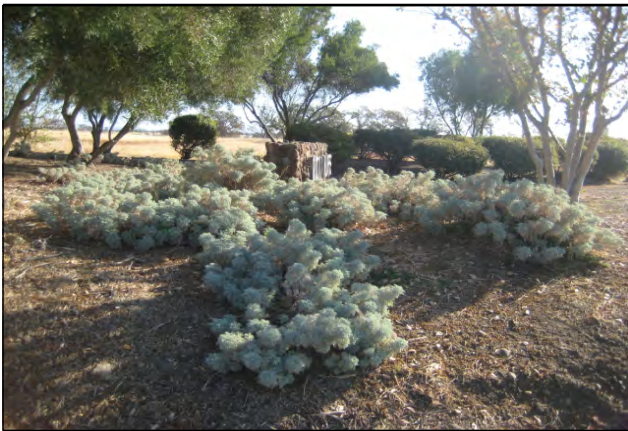
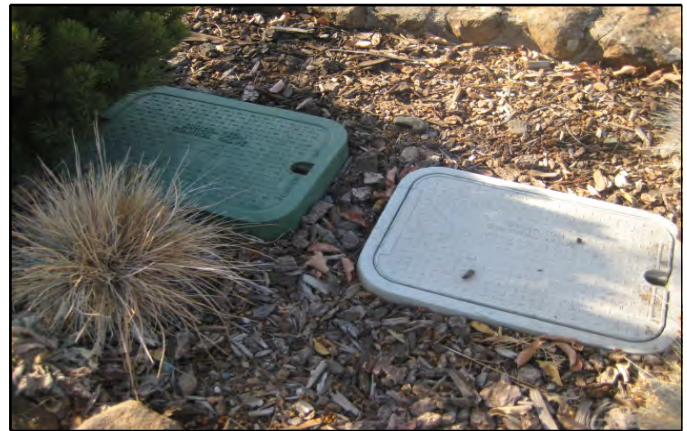
We were of significant recent landscape upgrades with additional plans for upcoming tree and landscape maintenance. Although difficult to predict timing and scope of work, best to plan for regular cycles of landscape/irrigation upgrades.

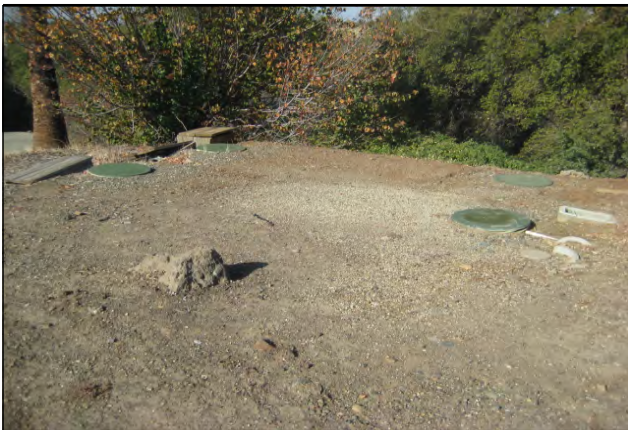
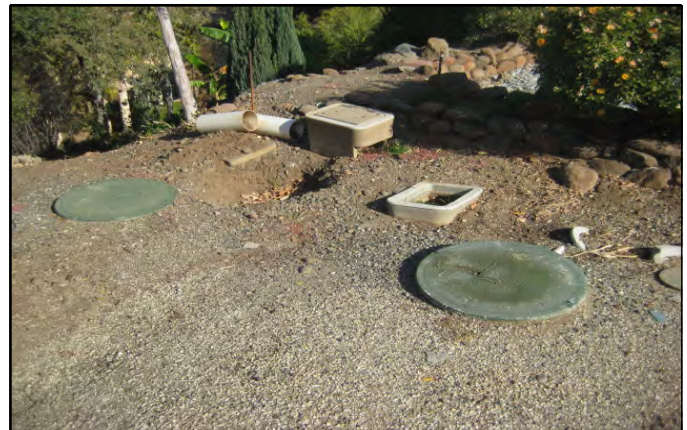
Comp # 2001 Septic System - Repair

Although difficult to predict timing, eventual cycles of significant repair will be needed. This component represents a reserve fund for future cycles of repair to the septic system.
