Rocky Bluffs Property Owners Association

Level 2 Reserve Study

Client Reference Number	17441
Property Type	PUD
Number of Units	42
Fiscal Year End	12/31
Type of Study	Update with Site Visit
Date of Site Visit	2/24/2024
Prepared By	Eric Phillipps
Analysis Method	Cash Flow
Funding Goal	Full Funding

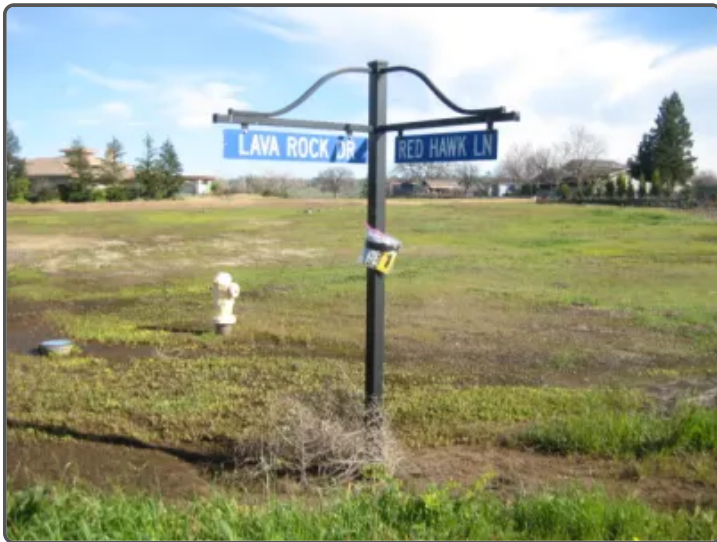
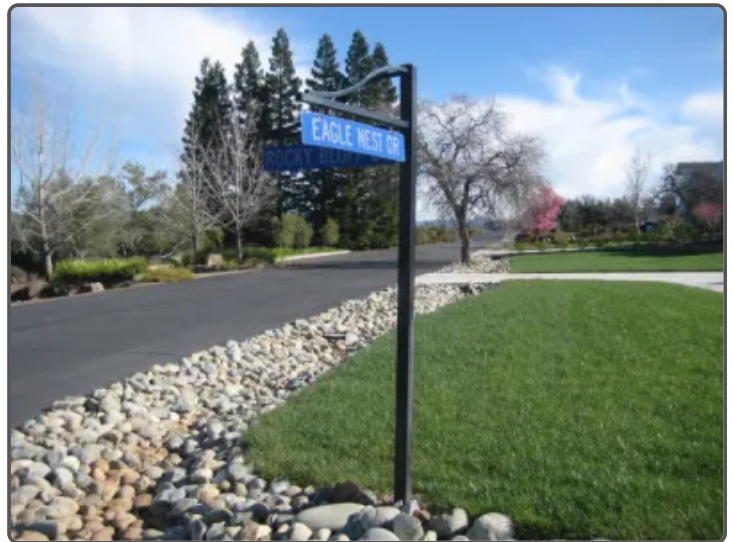
Comp # 213 Street Sign Poles - Paint (Operating Expense)

Due to moderate amount of sign posts, this component is typically a lower cost item and can be maintained as-needed through the operating/maintenance budget.

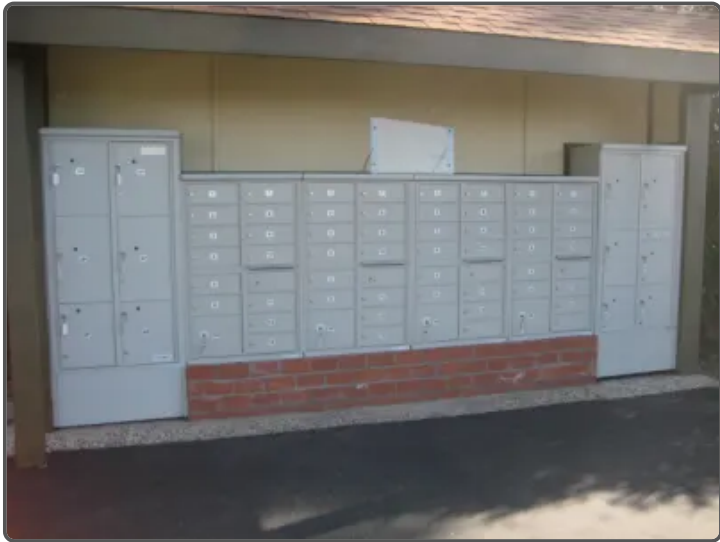
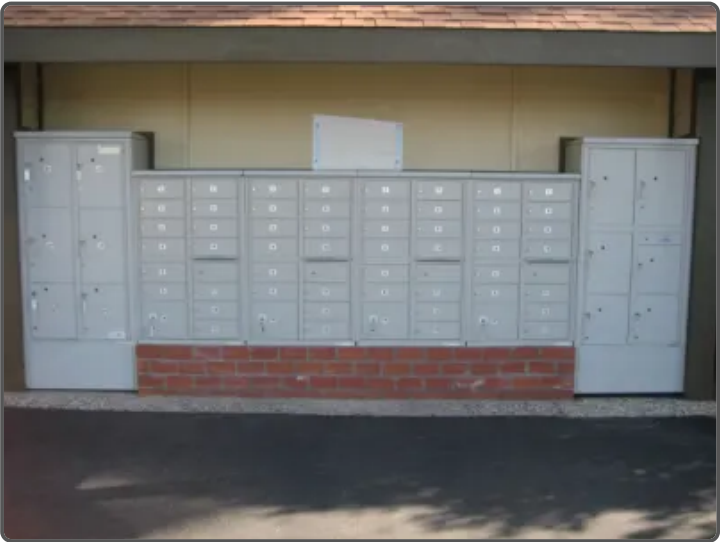
Exterior metal surfaces will require regular cycles of paint/sealant to help prevent corrosion. New mailboxes were recently installed. This component has an approximate useful life of 4-6 years. The remaining useful life is based on the installation date

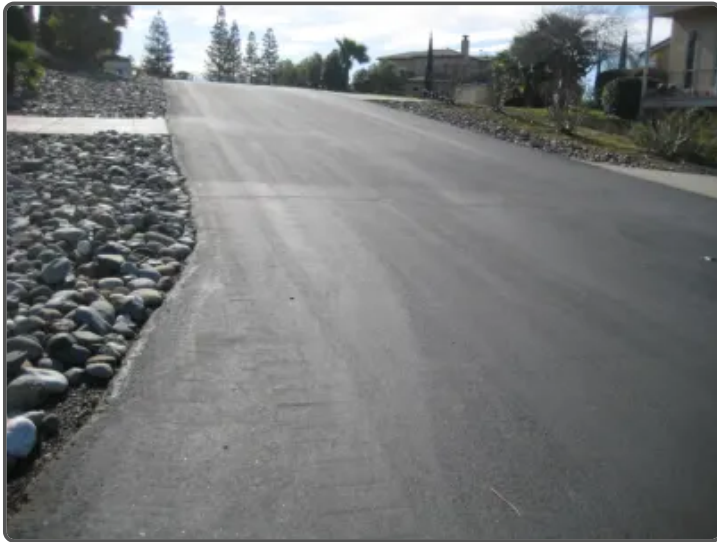
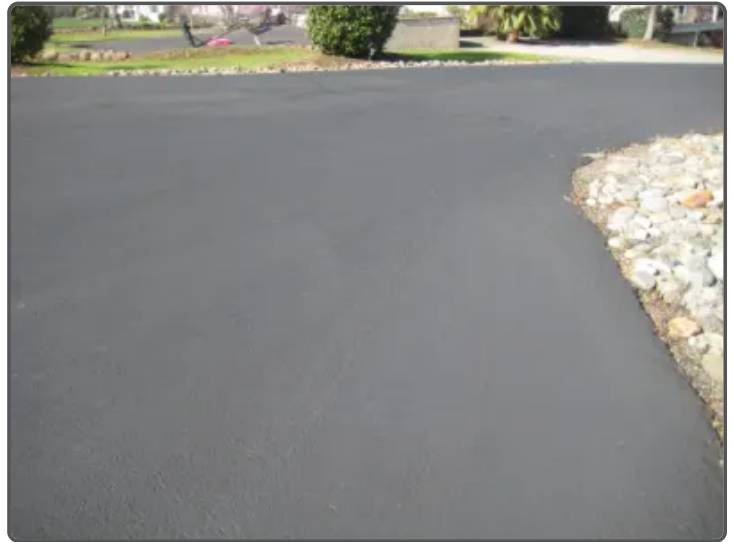
Overall the asphalt at Osprey Circle appeared in generally good condition. With regular cycles of sealing and maintenance (see Comp# 405 Asphalt - Preventive Maintenance) these surfaces should reach a useful life of approximately 30-40 years. Remaining life based on the assumed age.

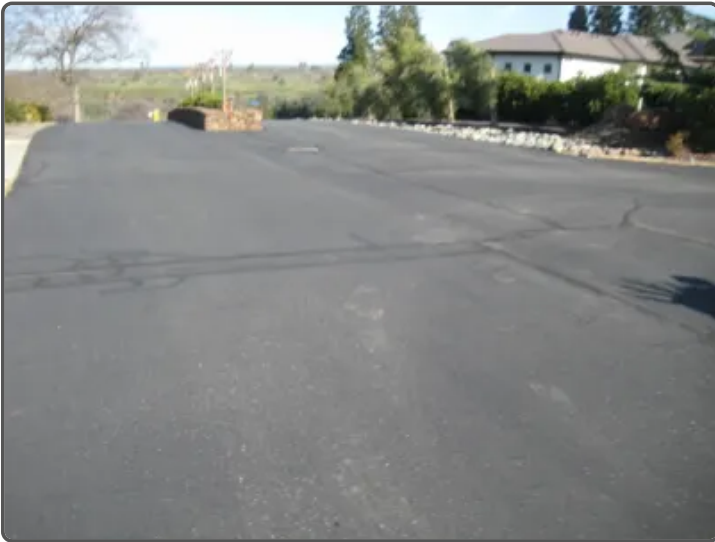
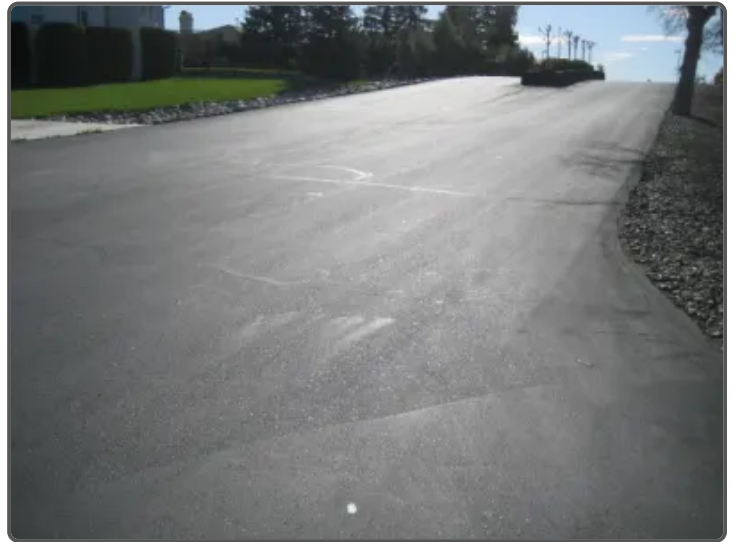
Overall the asphalt at Rocky Bluff Drive appeared in generally stable condition. With regular cycles of sealing and maintenance (see Comp# 405 Asphalt - Preventive Maintenance) these surfaces should reach a useful life of approximately 30-40 years. Remaining life based on the assumed age.

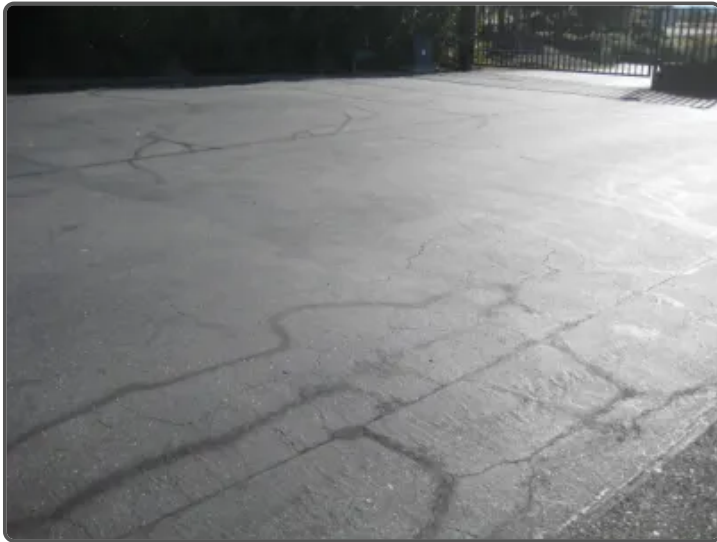
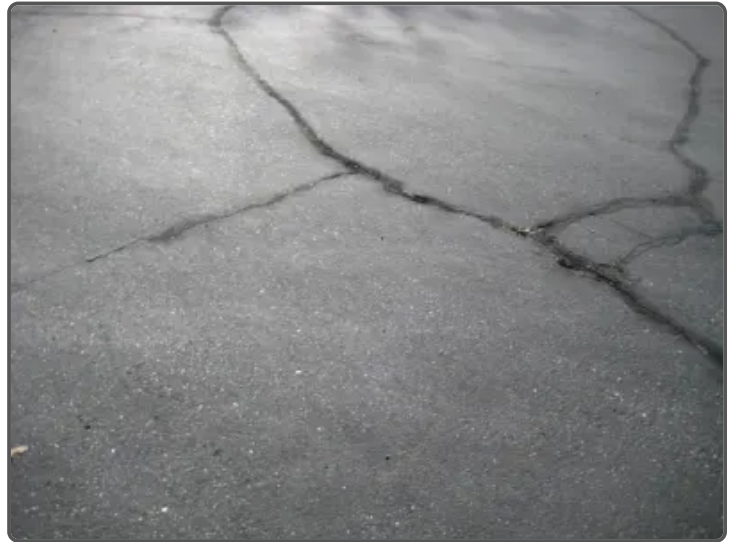
Regular cycles of preventive maintenance and asphalt seal coating are key to extending the typical useful life for major rehabilitation projects. This component typically has an approximate life of 4-6 years. Asphalt professionals typically recommend seal coating within six months to a year after major rehabilitation projects.

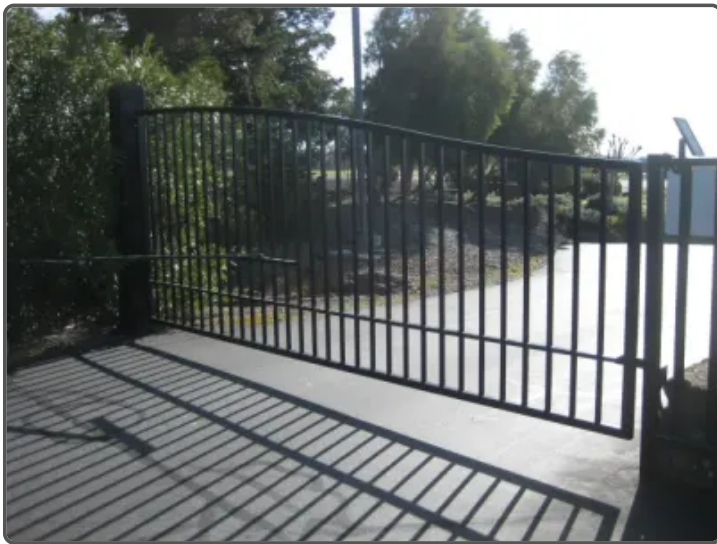
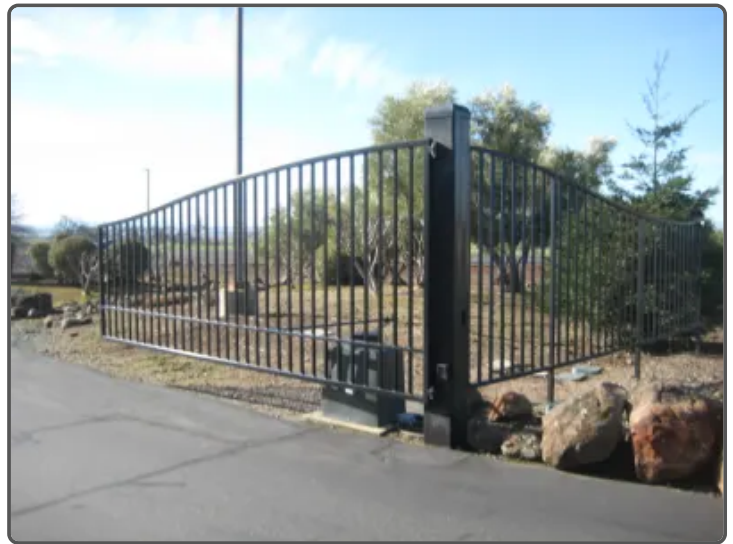
Comp # 504 Vehicle Gates - Replace

Although long lasting material, metal gates will require eventual replacement. Gates were reportedly recently replaced. This component has an approximate useful life of 25-35 years. The remaining useful life is based on the replacement date.

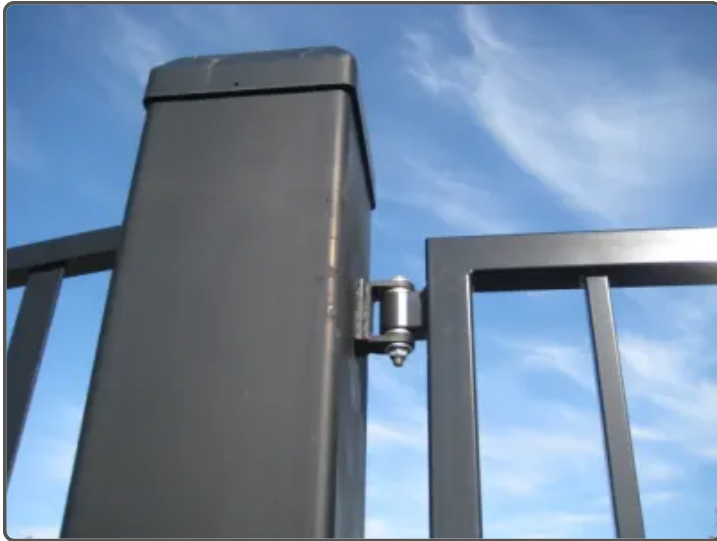
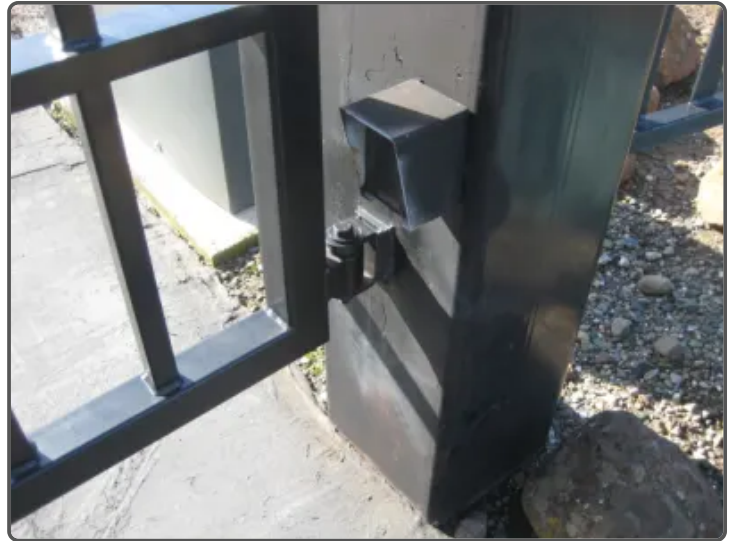
Comp # 505 Vehicle Gate Hinges - Repair/Replace

Functional condition observed, no problems reported. This component represents ongoing cycles of repair/replacement as gate hinges will wear out faster than other parts of the gate system.

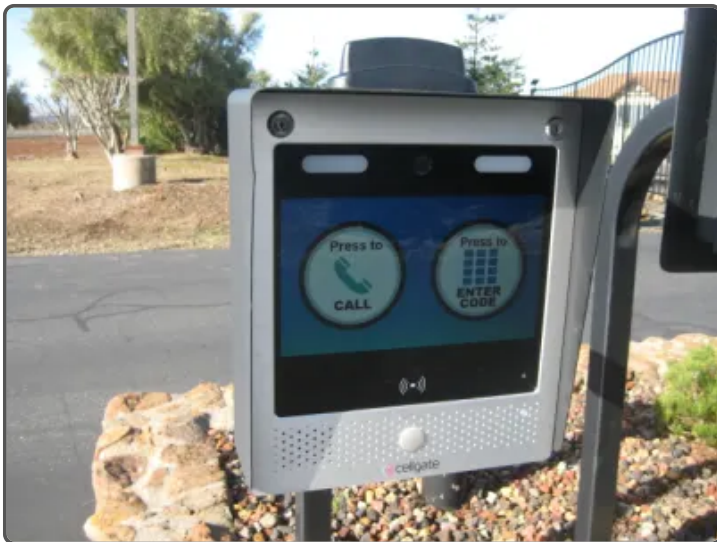
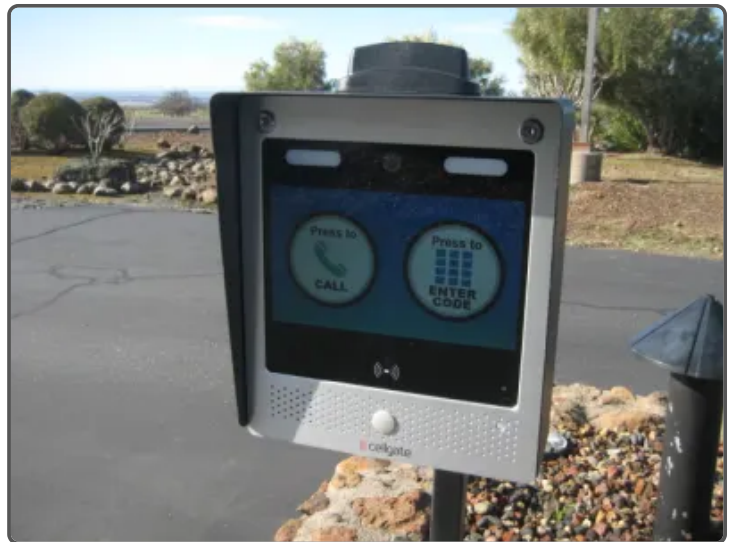
Comp # 506 Phone Entry Panel - Replace

Functional condition observed, no problems reported. The phone entry panel was reportedly recently replaced. This component has an approximate life of 10-20 years. The remaining useful life is based on the installation date.

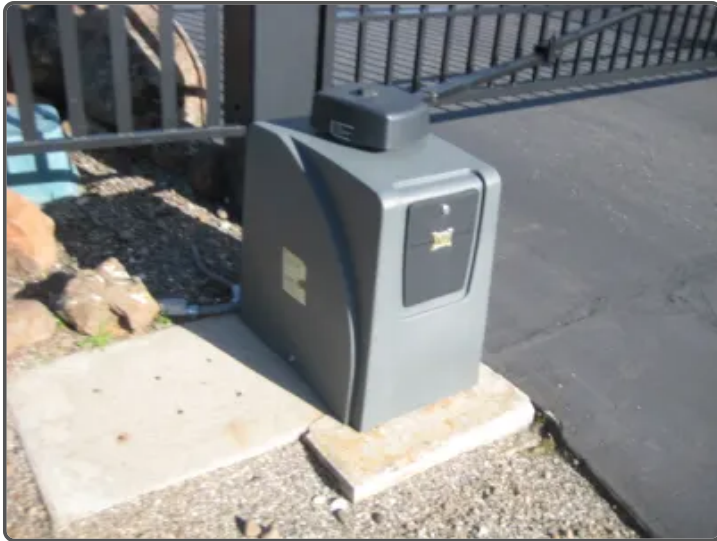
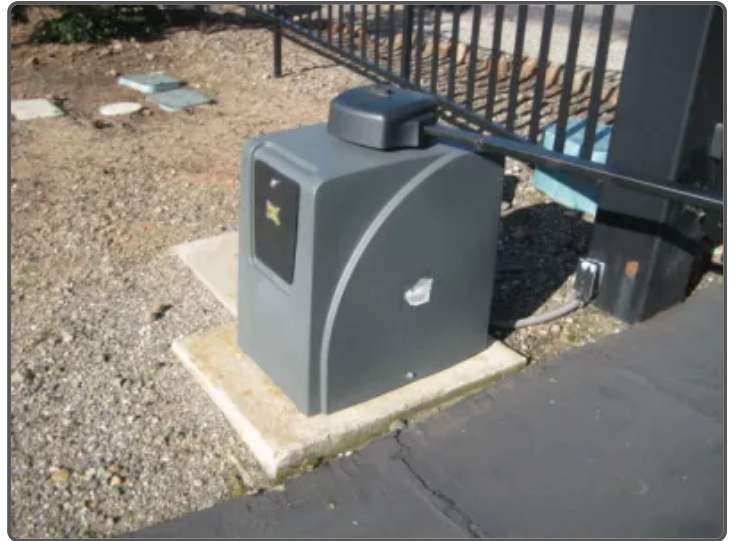
Comp # 507 Vehicle Gate Operator - Replace (A)

This operator was replaced in 2019 at a cost of \$4,878. This component has an approximate life of 10-20 years. The remaining useful life has been extended based on the installation date.

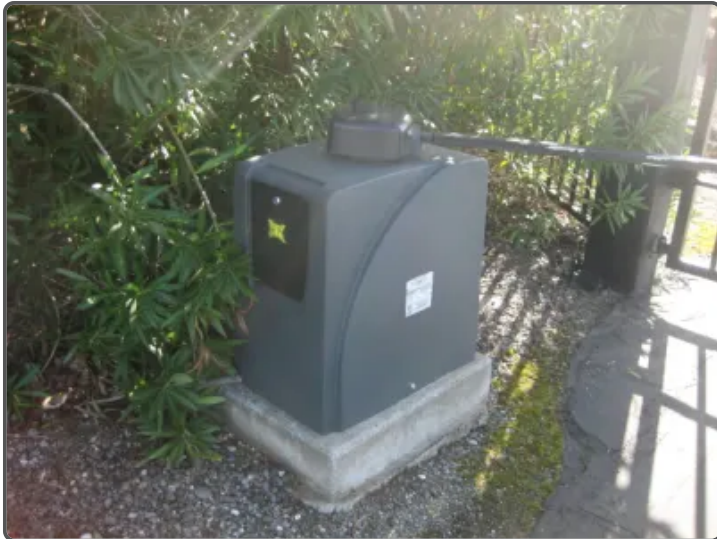
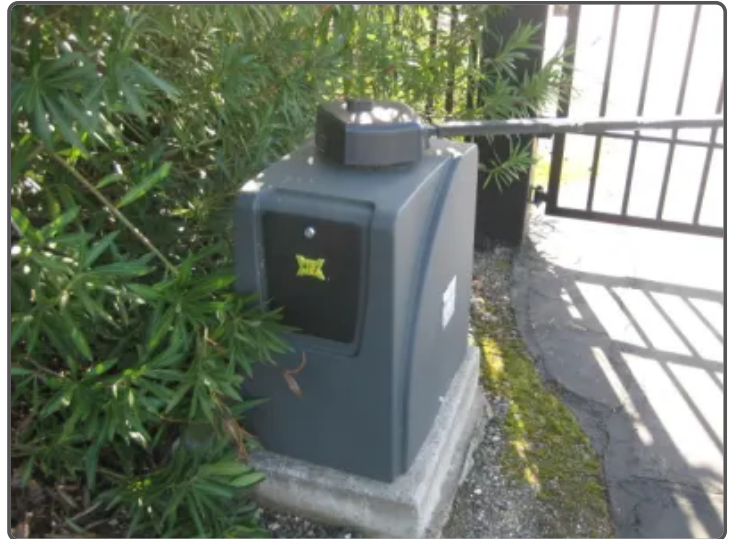
Comp # 508 Vehicle Gate Operator - Replace (B)

Functional condition observed, no problems reported. This operator was recently replaced and has an approximate life of 10-20 years. The remaining useful life has been extended based on the replacement date.

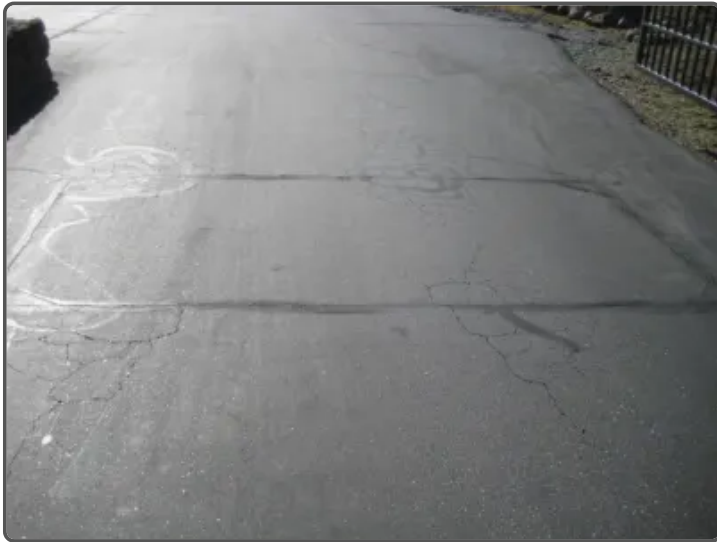
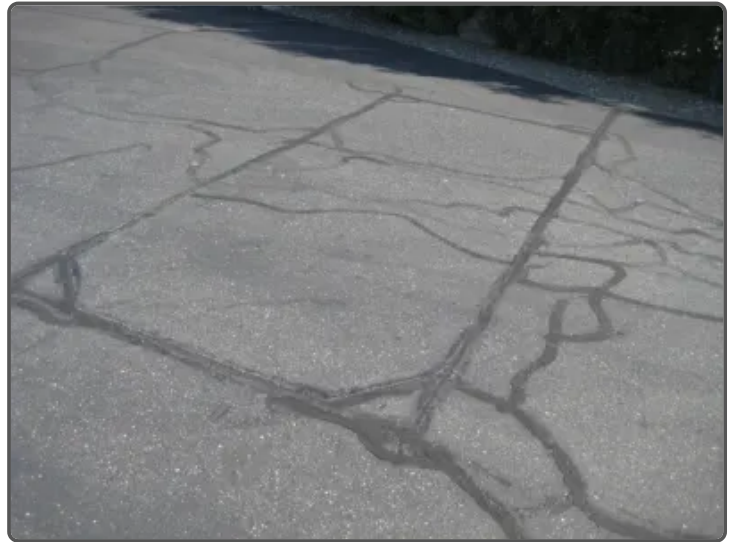
Comp # 509 Vehicle Gate Loops - Replace

This component represents a reserve allowance for eventual cycles of replacement of the vehicle gate loops. Best to replaced if needed prior to asphalt maintenance. Monitor life cycle and costs closely and adjust as-needed in reserve study updates.

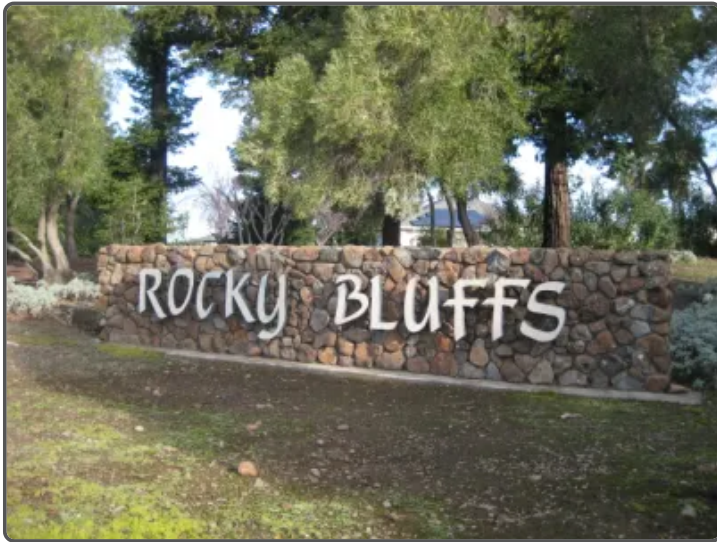
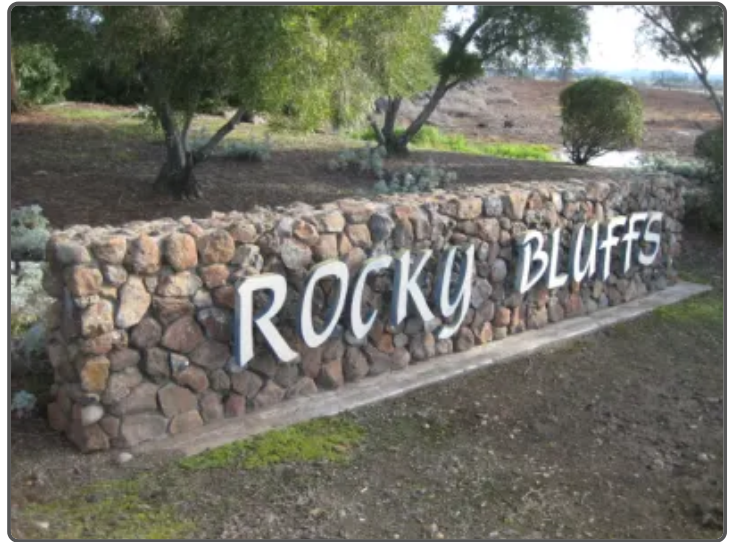
Comp # 801 Entry Monument - Refurbish

The entry monument was recently updated. Although there is no expectation to completely replace the monument/sign under normal circumstances, we recommend funding for significant refurbishment approximately every 20 to 30 years. The remaining life is based on the project date.

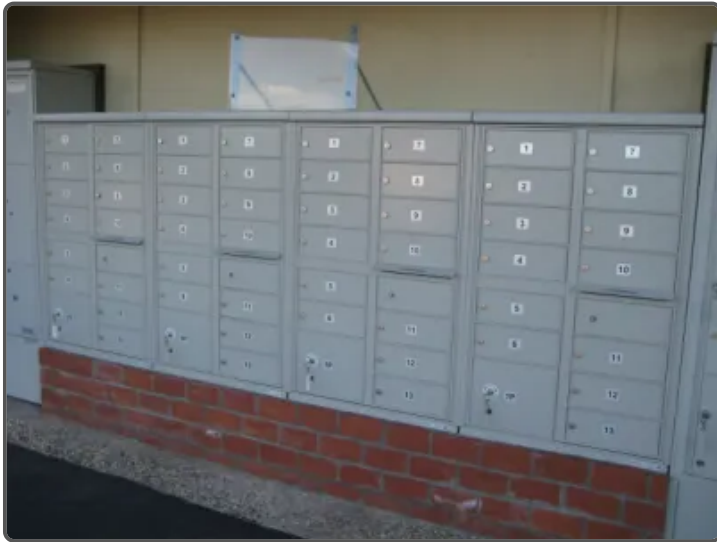
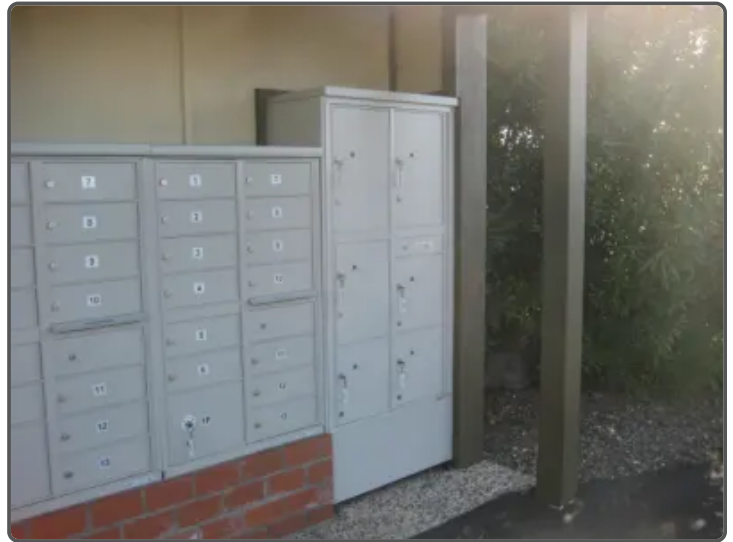
Comp # 803 Mailboxes - Replace

Although long lasting, mailboxes will require eventual replacement. The mailboxes were recently replaced. This component typically has an approximate useful life of 15-25 years. The remaining useful life is based on the installation date.

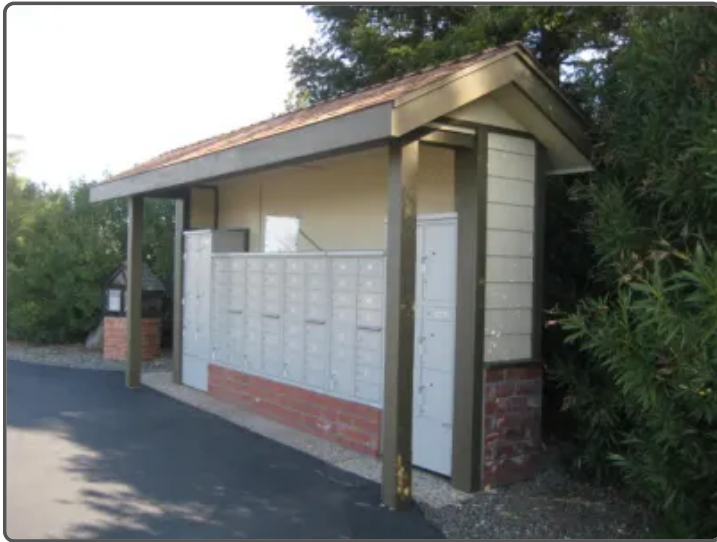
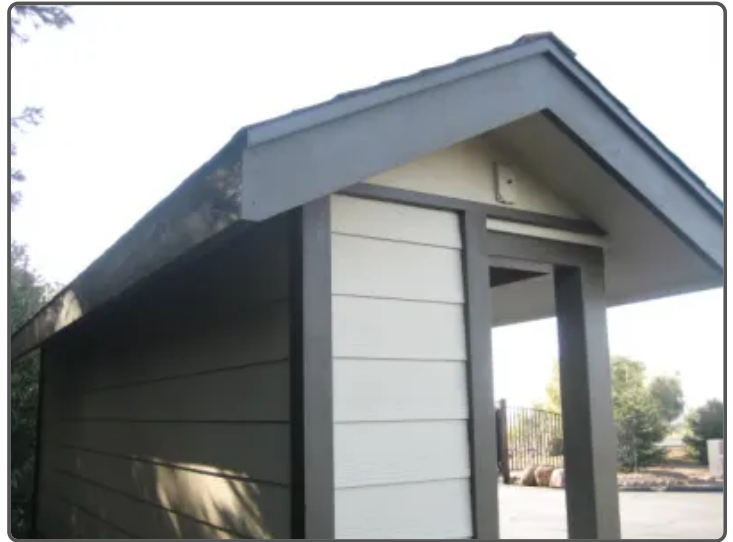
Comp # 804 Mailbox Kiosk - Replace

The mailbox kiosk was recently installed. Although the masonry should have extensive life, the fiber-cement siding, wood trim and composition asphalt shingle roof will require eventual cycles of significant repair and replacement. Best to plan for upgrades to siding and roofing at roughly the time frame indicated

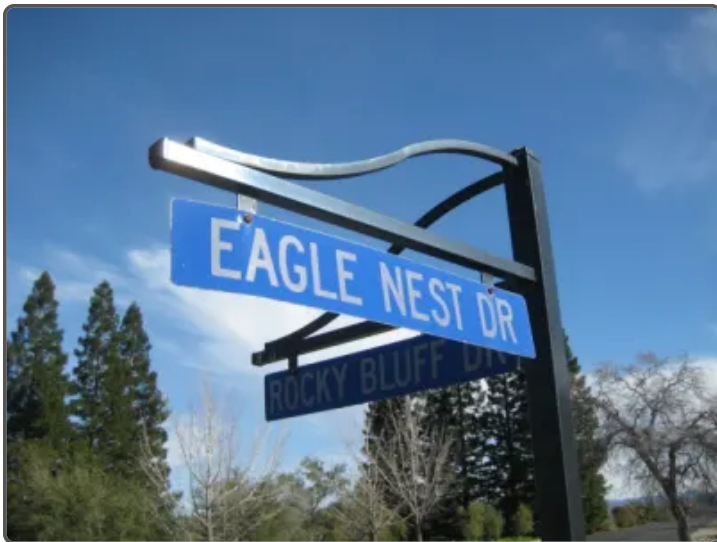
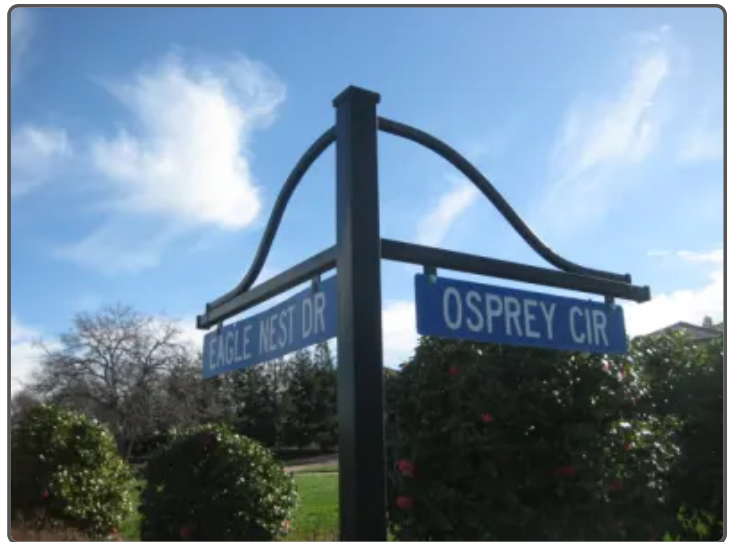
Comp # 808 Street Signs - Replace

Street signs were reportedly recently replaced. This component has an approximate life of 15-25 years. Remaining useful life has been extended based on installation date.

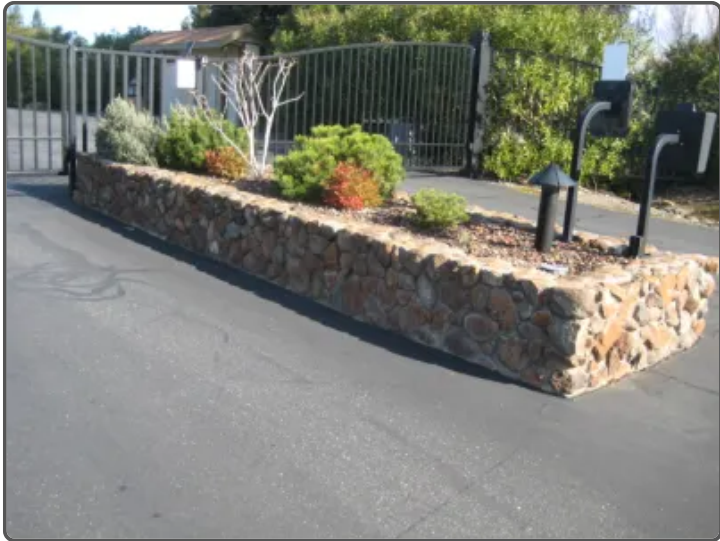
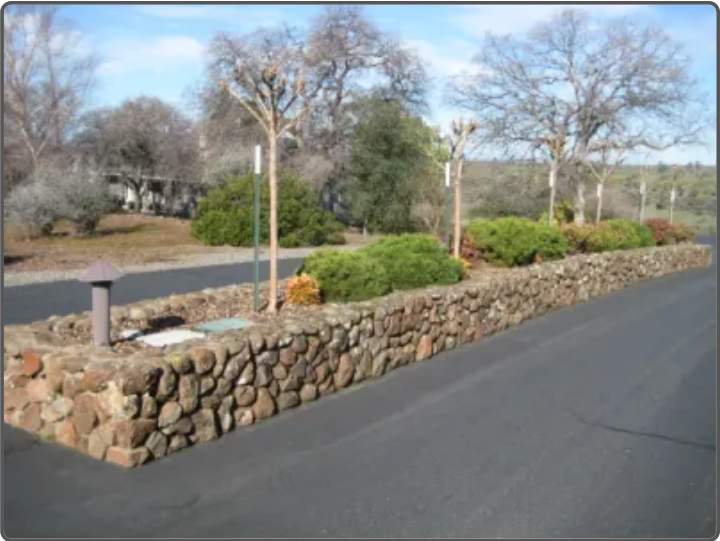
Comp # 1090 Stone Façades - Repair

This component represents cycles of repair to the stone façade planters on Rocky Bluff Drive. Monitor expenses closely and adjust as needed in reserve study updates.

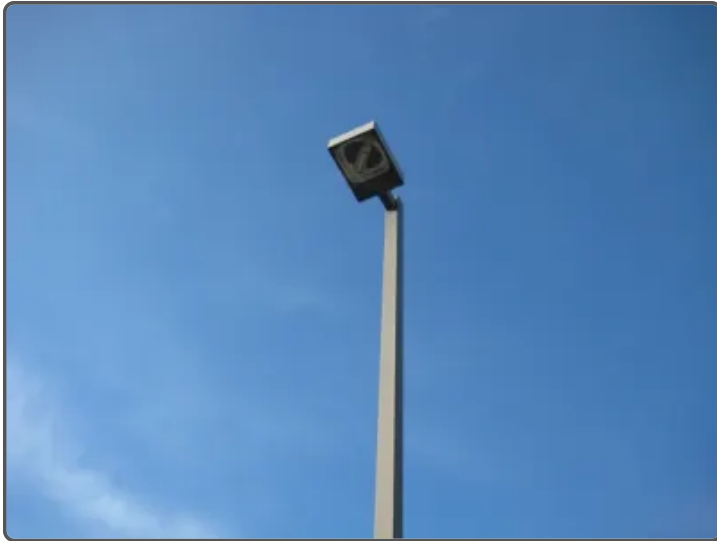
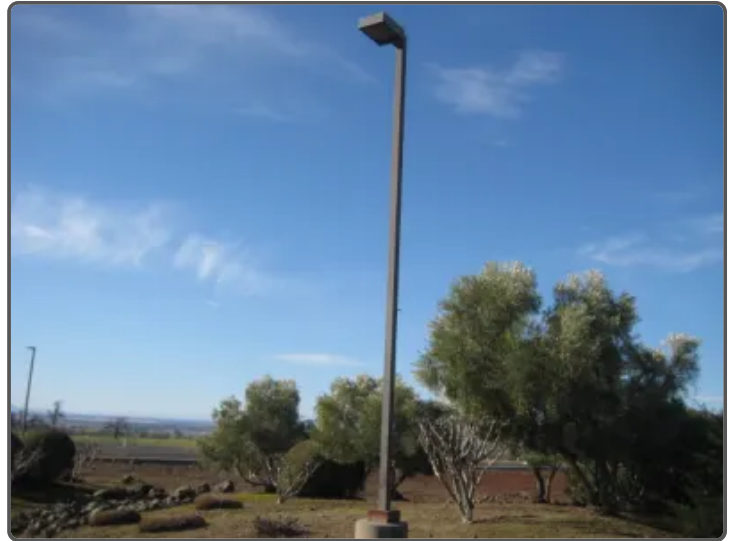
Comp # 1604 Pole Lights - Replace

Although pole lights and fixtures typically have an extended life, best to plan for eventual replacement. This component has an approximate useful life of 30-40 years. The remaining useful life is based on the assumed age.

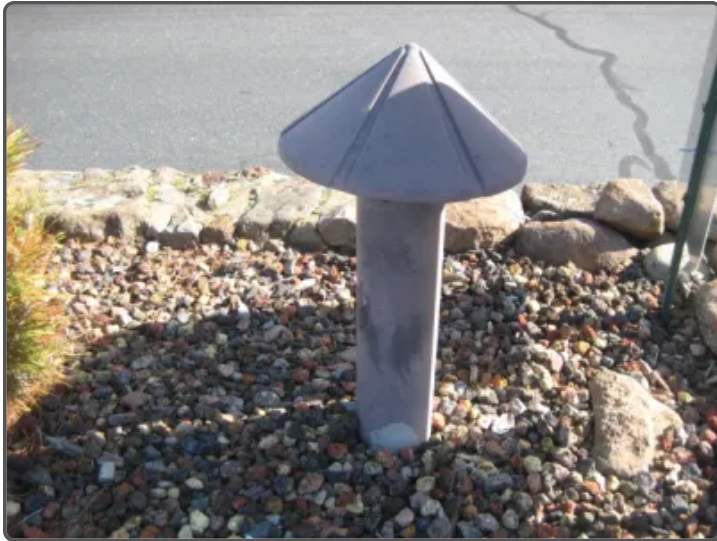
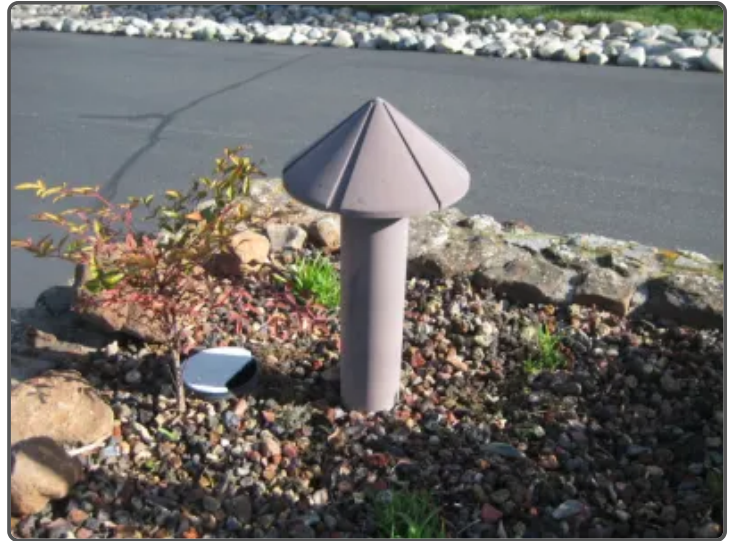
Comp # 1605 **Mushroom Metal Lights - Replace**

Observed during daylight hours, functional condition assumed. This component has an approximate useful life of 10-20 years. The remaining useful life is based on the assumed age.

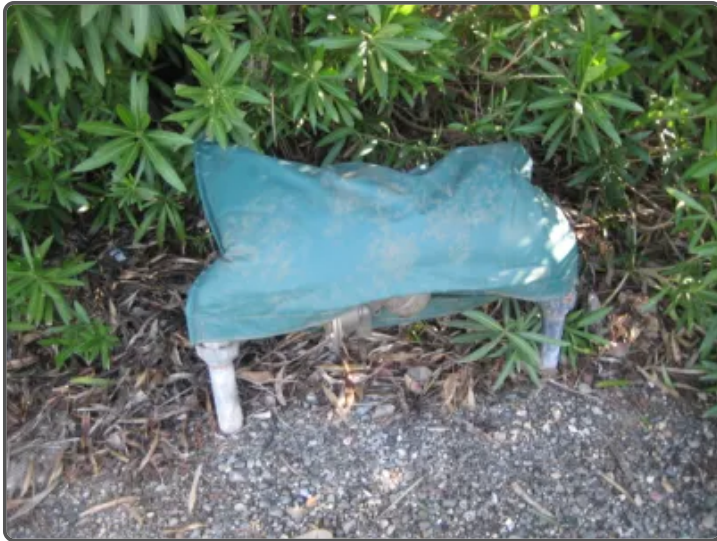
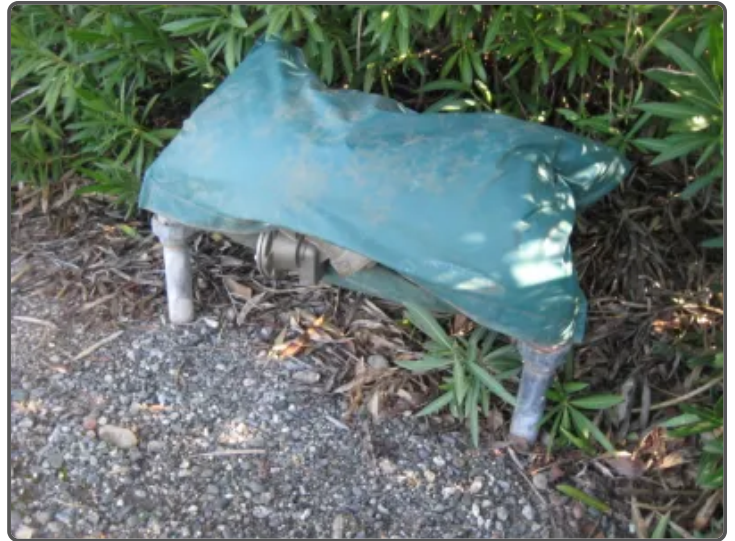
Comp # 1790 Backflow Device - Replace

No problems reported. We recommend replacing backflow device every 20-30 years. The remaining useful life is based on the assumed age.

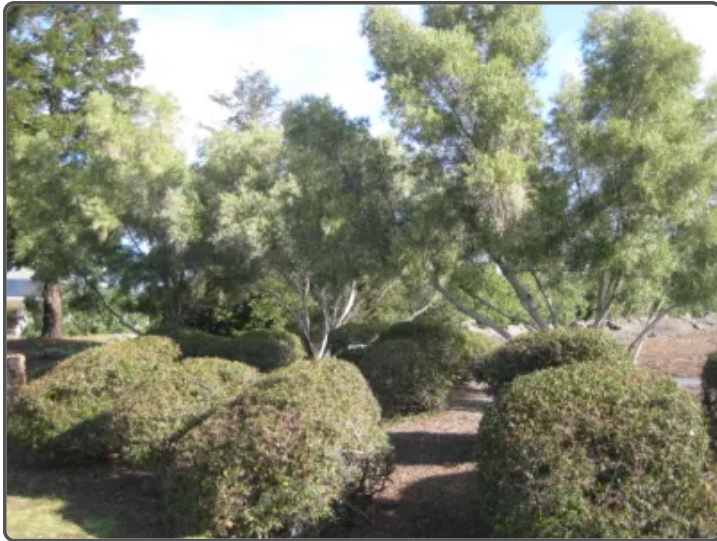
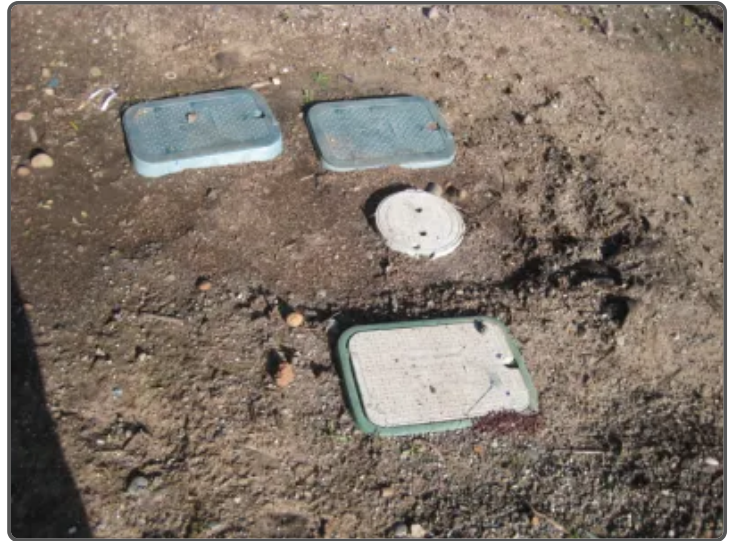
We were informed of recent landscape upgrades. Although difficult to predict timing and scope of work, best to plan for regular cycles of landscape/irrigation upgrades.

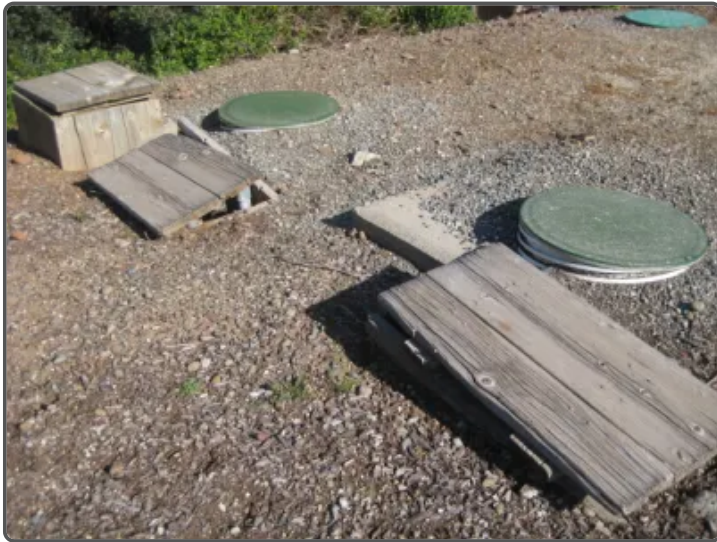
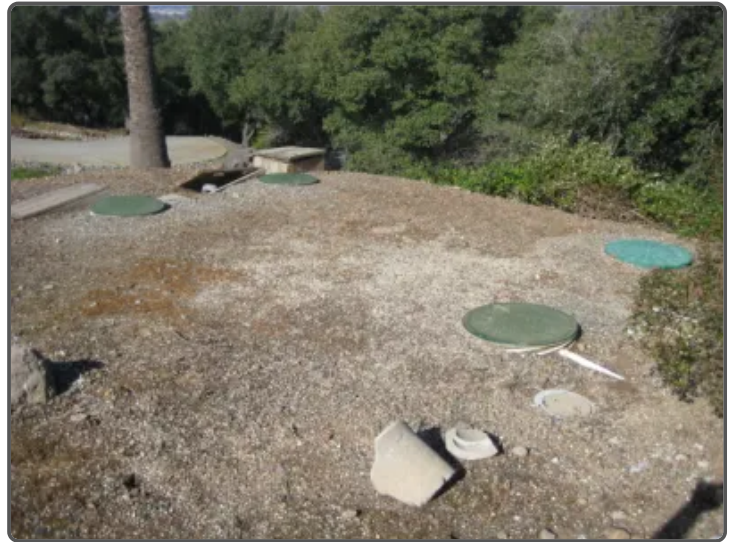
Comp # 2001 Main Distribution Soil Filter 3 - Repair

Per North Star and Hydrotec Solutions, the Main Distribution for Soil Filter 3 is damaged and required immediate attention. This component represents a reserve funding allowance for repair. Monitor actual expense and adjust in future reserve study update.

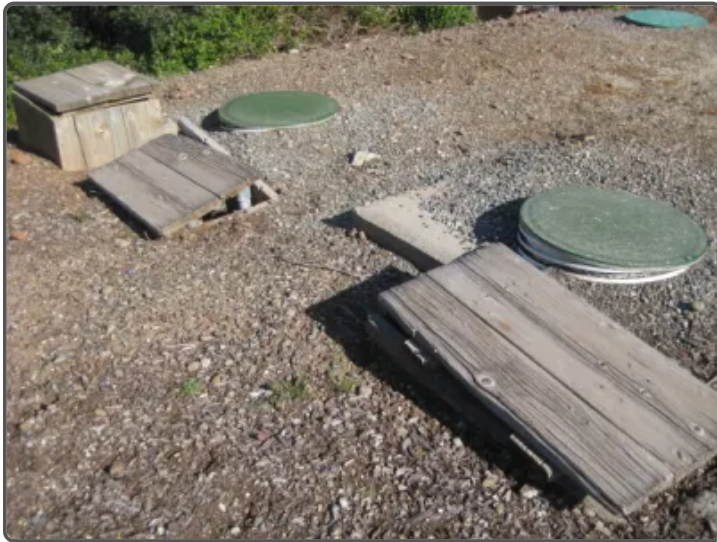
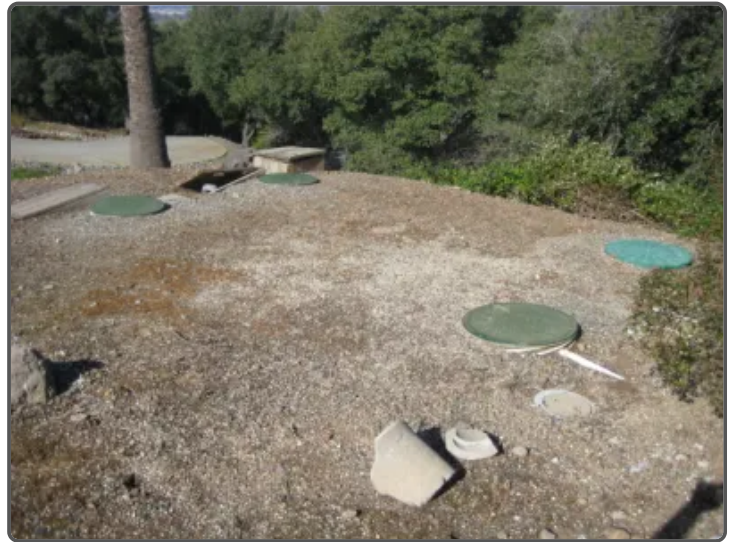
Comp # 2002 Main Distribution Soil Filter 2 - Repair

Per North Star and Hydrotec Solutions, the Main Distribution for Soil Filter 2 is damaged and required immediate attention. This component represents a reserve funding allowance for repair. Monitor actual expense and adjust in future reserve study update.

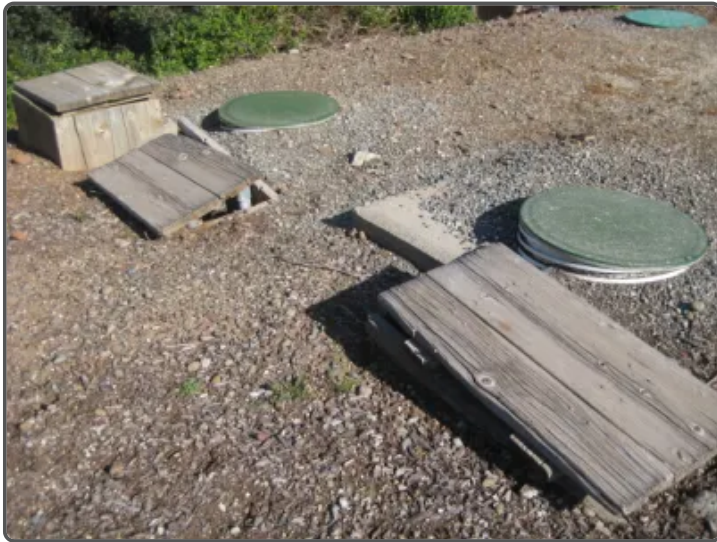
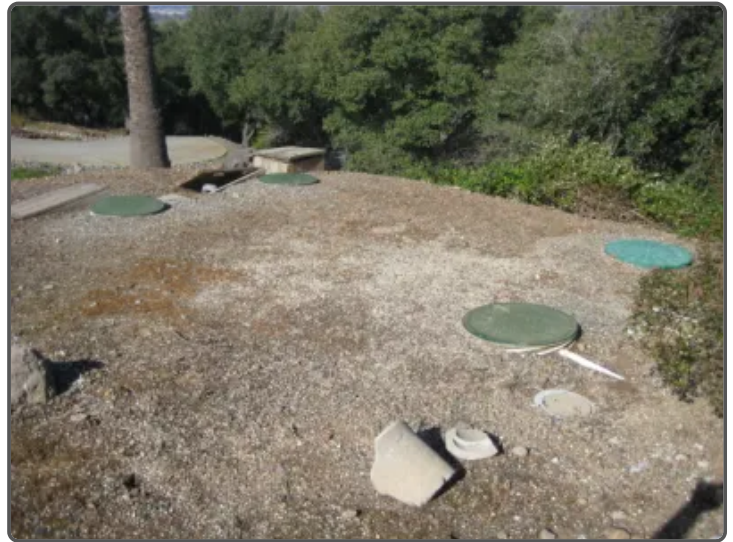
Comp # 2003 North Dosing Tank - Repair

Per North Star and Hydrotec Solutions, the North Dosing Tank is leaking around the siphoning outlet and will require eventual repair. This component represents a reserve funding allowance for repair. Monitor actual expense and adjust in future reserve study update.

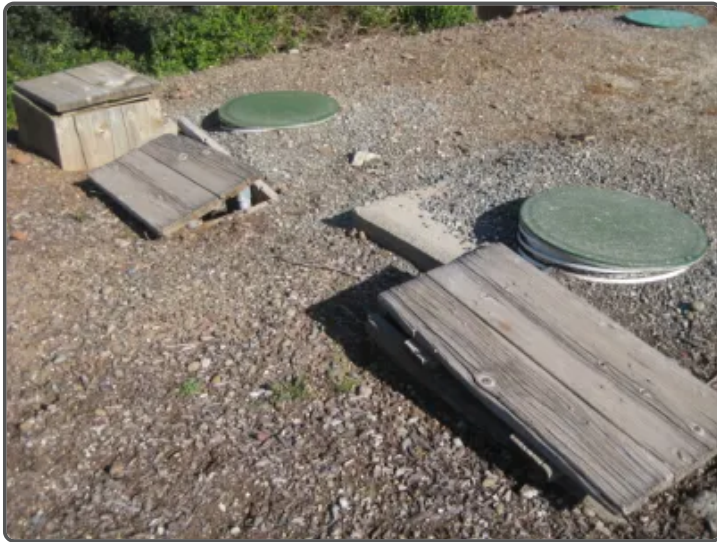
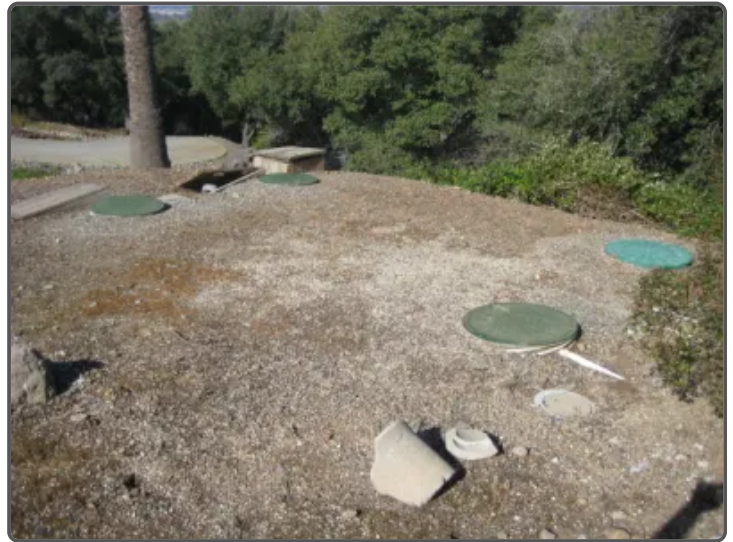
Comp # 2004 South Dosing Tank - Repair

Per North Star and Hydrotec Solutions, the South Dosing Tank is showing signs of degradation and will require eventual repair. This component represents a reserve funding allowance for repair. Monitor actual expense and adjust in future reserve study update.

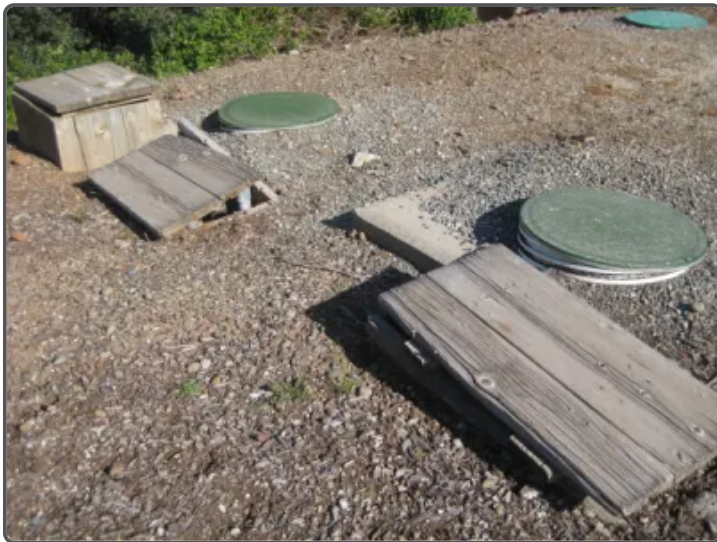
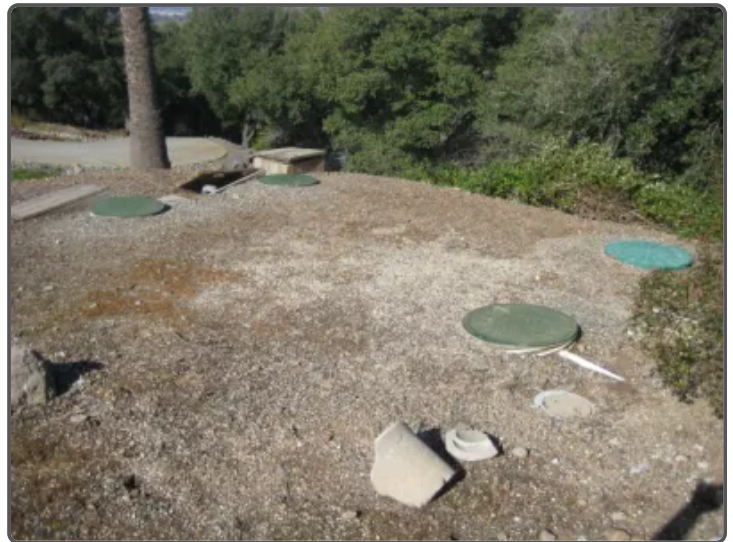
Comp # 2005 North & South Dosing Tanks - Replace

Per North Star and Hydrotec Solutions, the North and South Dosing tanks will require eventual replacement. This estimate includes (2) 3,000 gallon tank replacements with dosing siphons, inlet manifold reconstruction, design, permitting, crane set, construction inspection, inlet force manifold, dosing pumps and electrical services. Monitor actual expense and adjust in future reserve study update.
